## 3. General Overview of Storm-Related Damage

This chapter presents a general overview of typical types of damage that resulted from Hurricane Katrina, as well as the effects caused by flood and wind damage. Section 3.1 characterizes flood damages observed by the MAT, with additional discussion and examples provided by different types of building occupancy (e.g., one- and two-family residential buildings, multi-family residential buildings, commercial buildings, critical and essential facilities, and historic buildings). Section 3.2 includes a similar treatment and breakdown for wind effects. More detailed discussions of the observations are presented in Chapters 4, 5, 6, and 7.

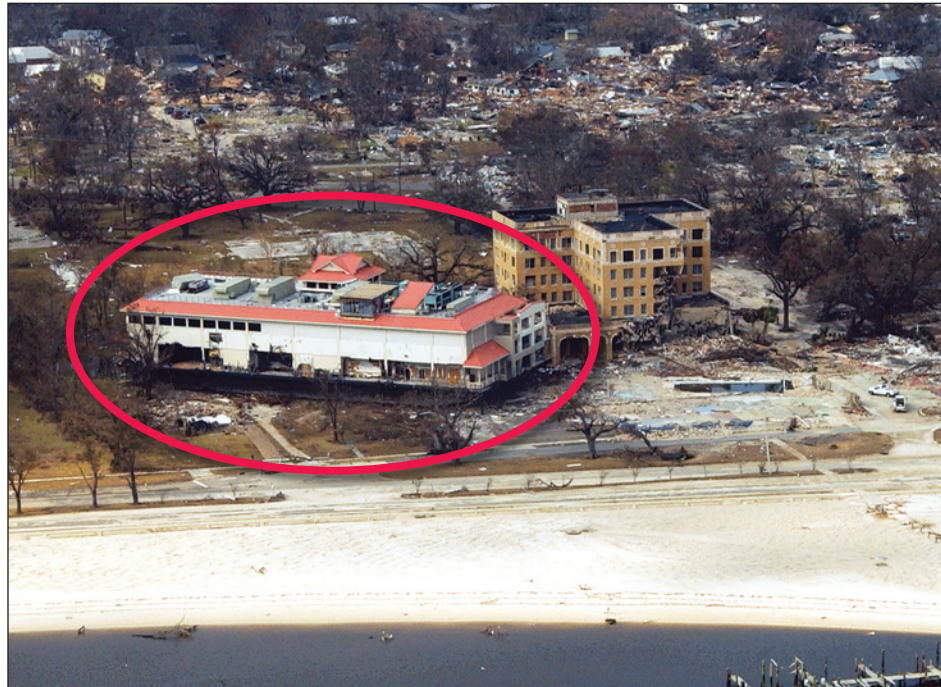
**Figure 3-2.**  
Displaced casino barge floated inland, struck and came to rest near a hotel along U.S. 90 (Biloxi, Mississippi)

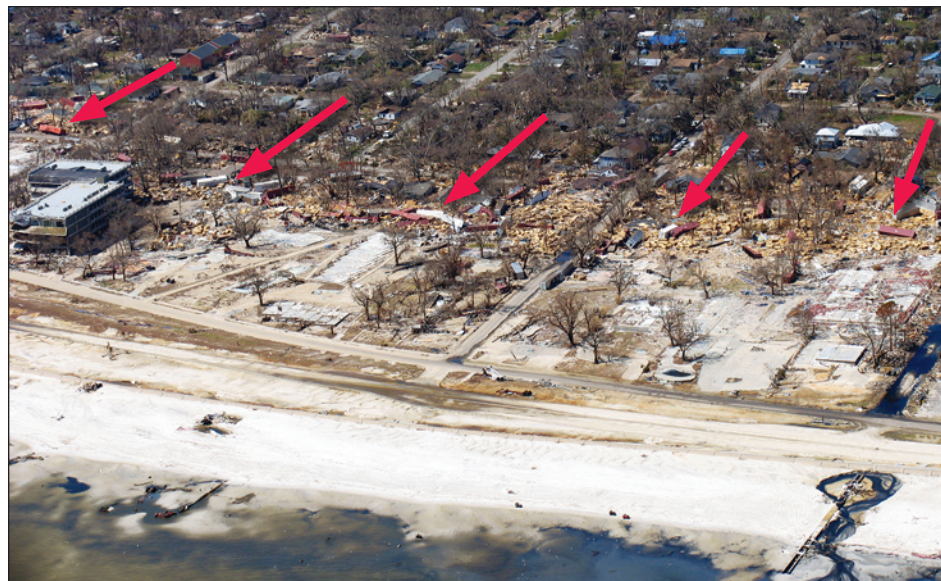
**Figure 3-3.**  
A major element of debris in this debris field was shipping containers from the port (arrows indicate examples) (Gulfport, Mississippi).

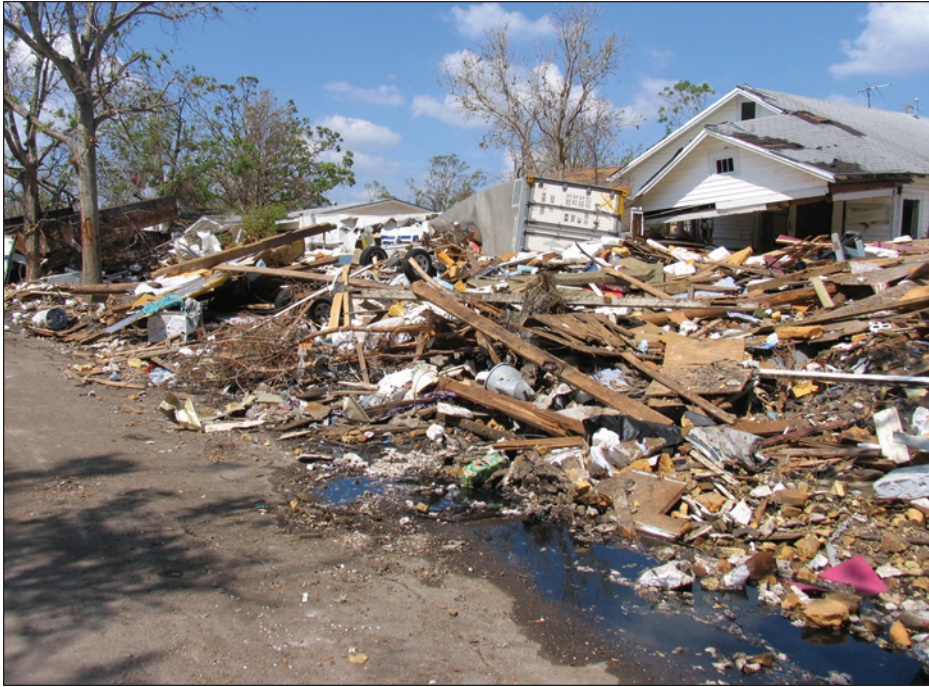
**Figure 3-4.**  
Floodborne debris,  
including shipping  
containers and sections  
of destroyed buildings  
(Gulfport, Mississippi)

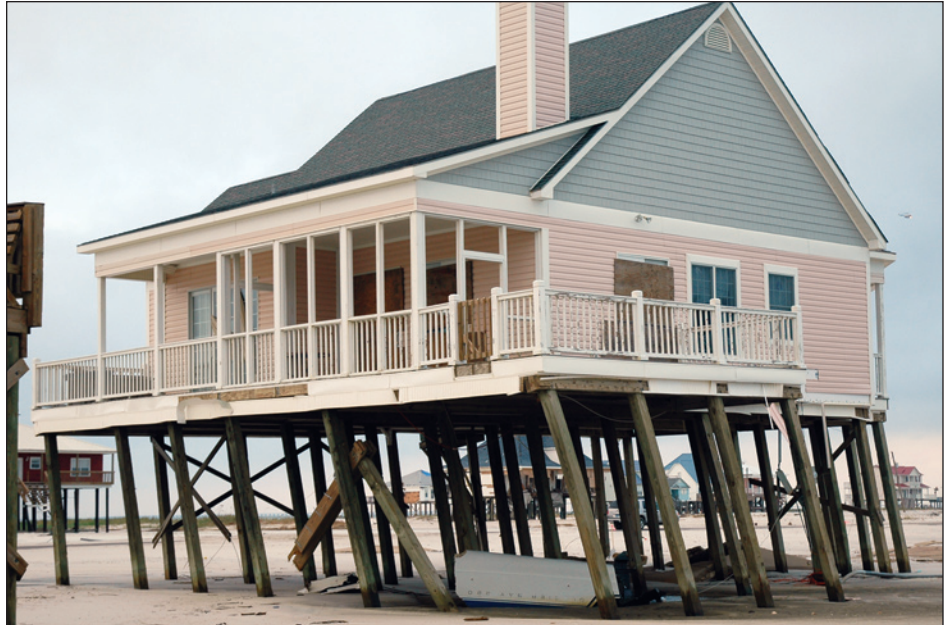
**Figure 3-5.**  
House on verge of collapse due to shallow embedment of timber pile foundation (Dauphin Island, Alabama)

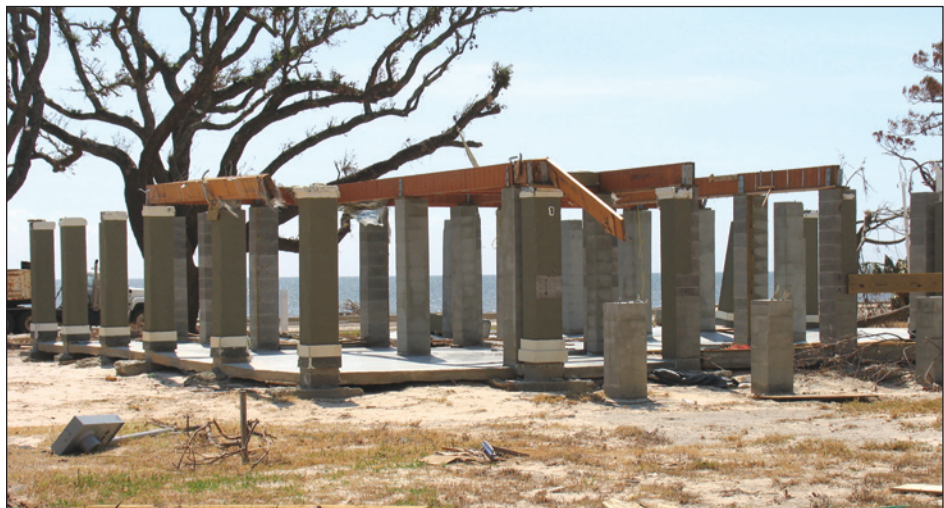
**Figure 3-6.**  
Elevated house atop masonry pier foundation was lost, probably due to waves and storm surge reaching above the top of the foundation (Long Beach, Mississippi)

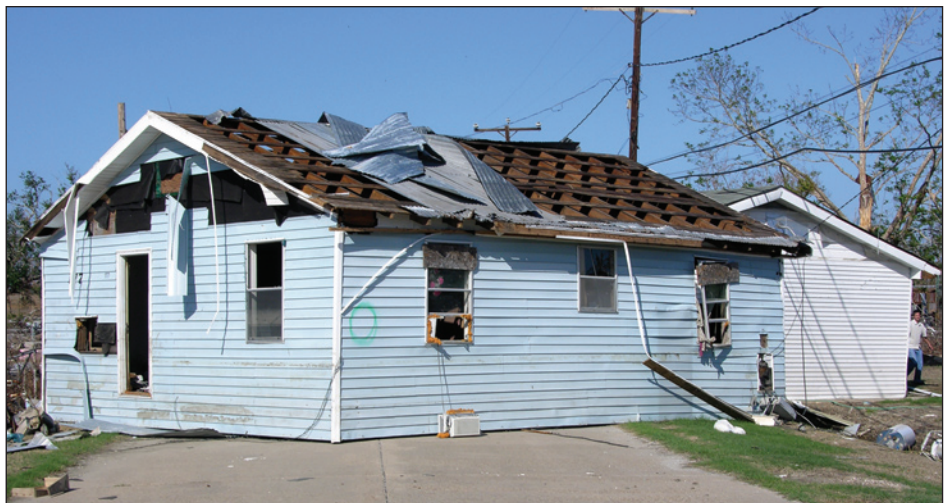
**Figure 3-7.**  
Building floated off of foundation (Happy Jack, Louisiana)

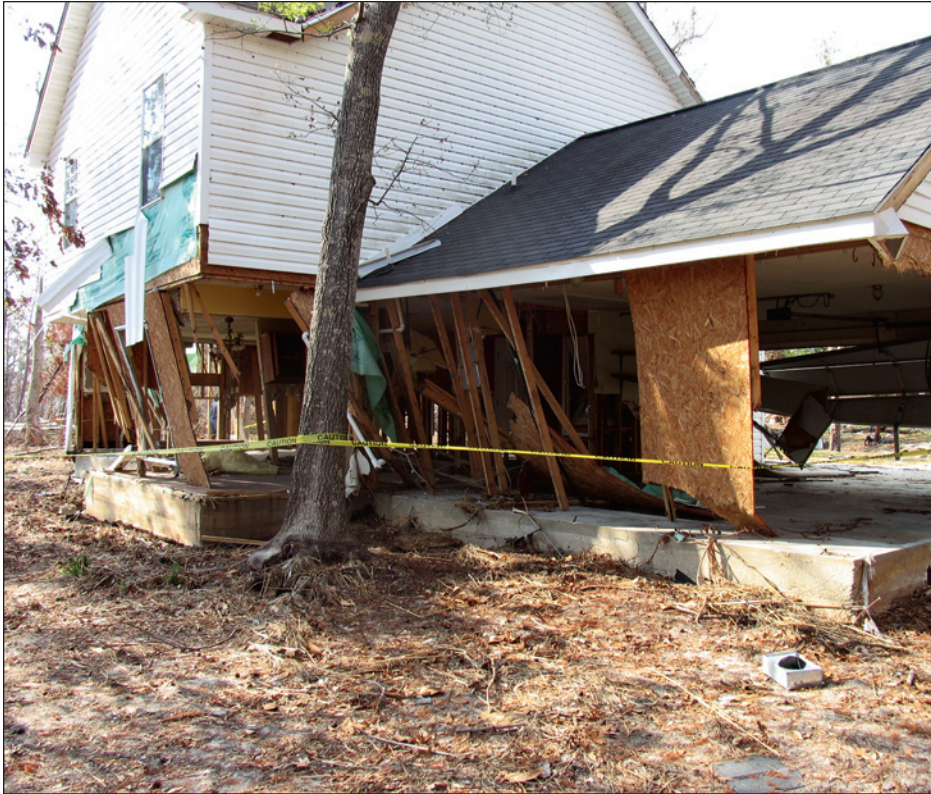
Figure 3-8.  
Wave and surge  
damage to load-  
bearing walls atop  
stem wall foundation.  
The house was located  
in flood hazard zone  
C, approximately 1/4  
mile from the shoreline  
(Pointe Aux Chens  
area, Jackson County,  
Mississippi).

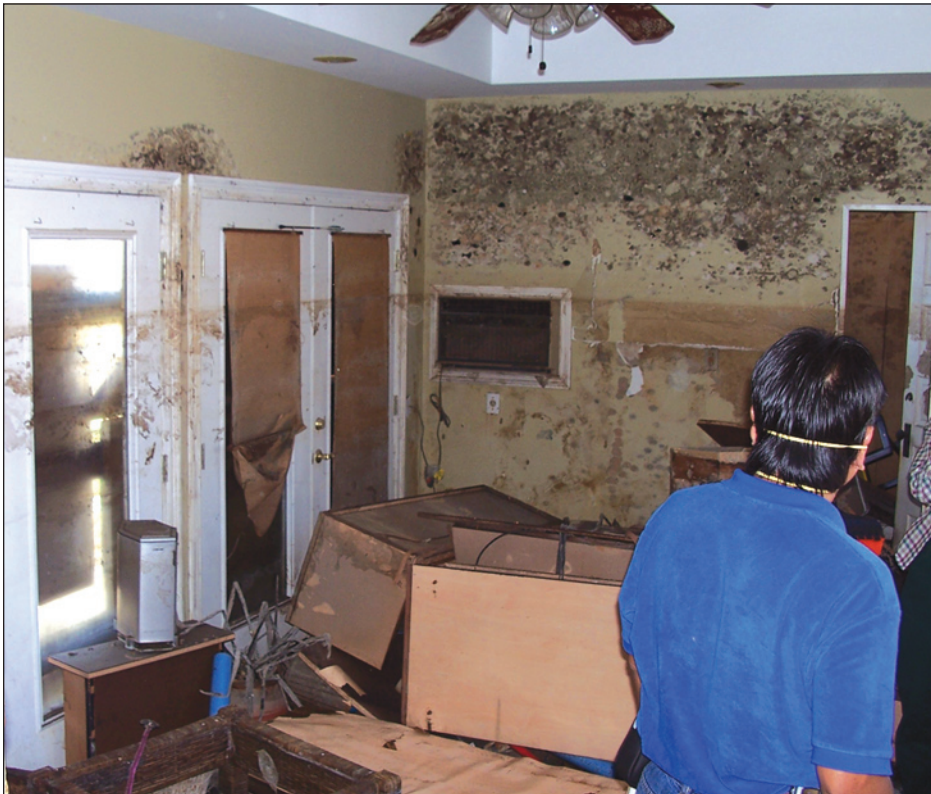
Figure 3-9.  
Interior damage and  
mold from prolonged  
flooding (New Orleans,  
Louisiana)

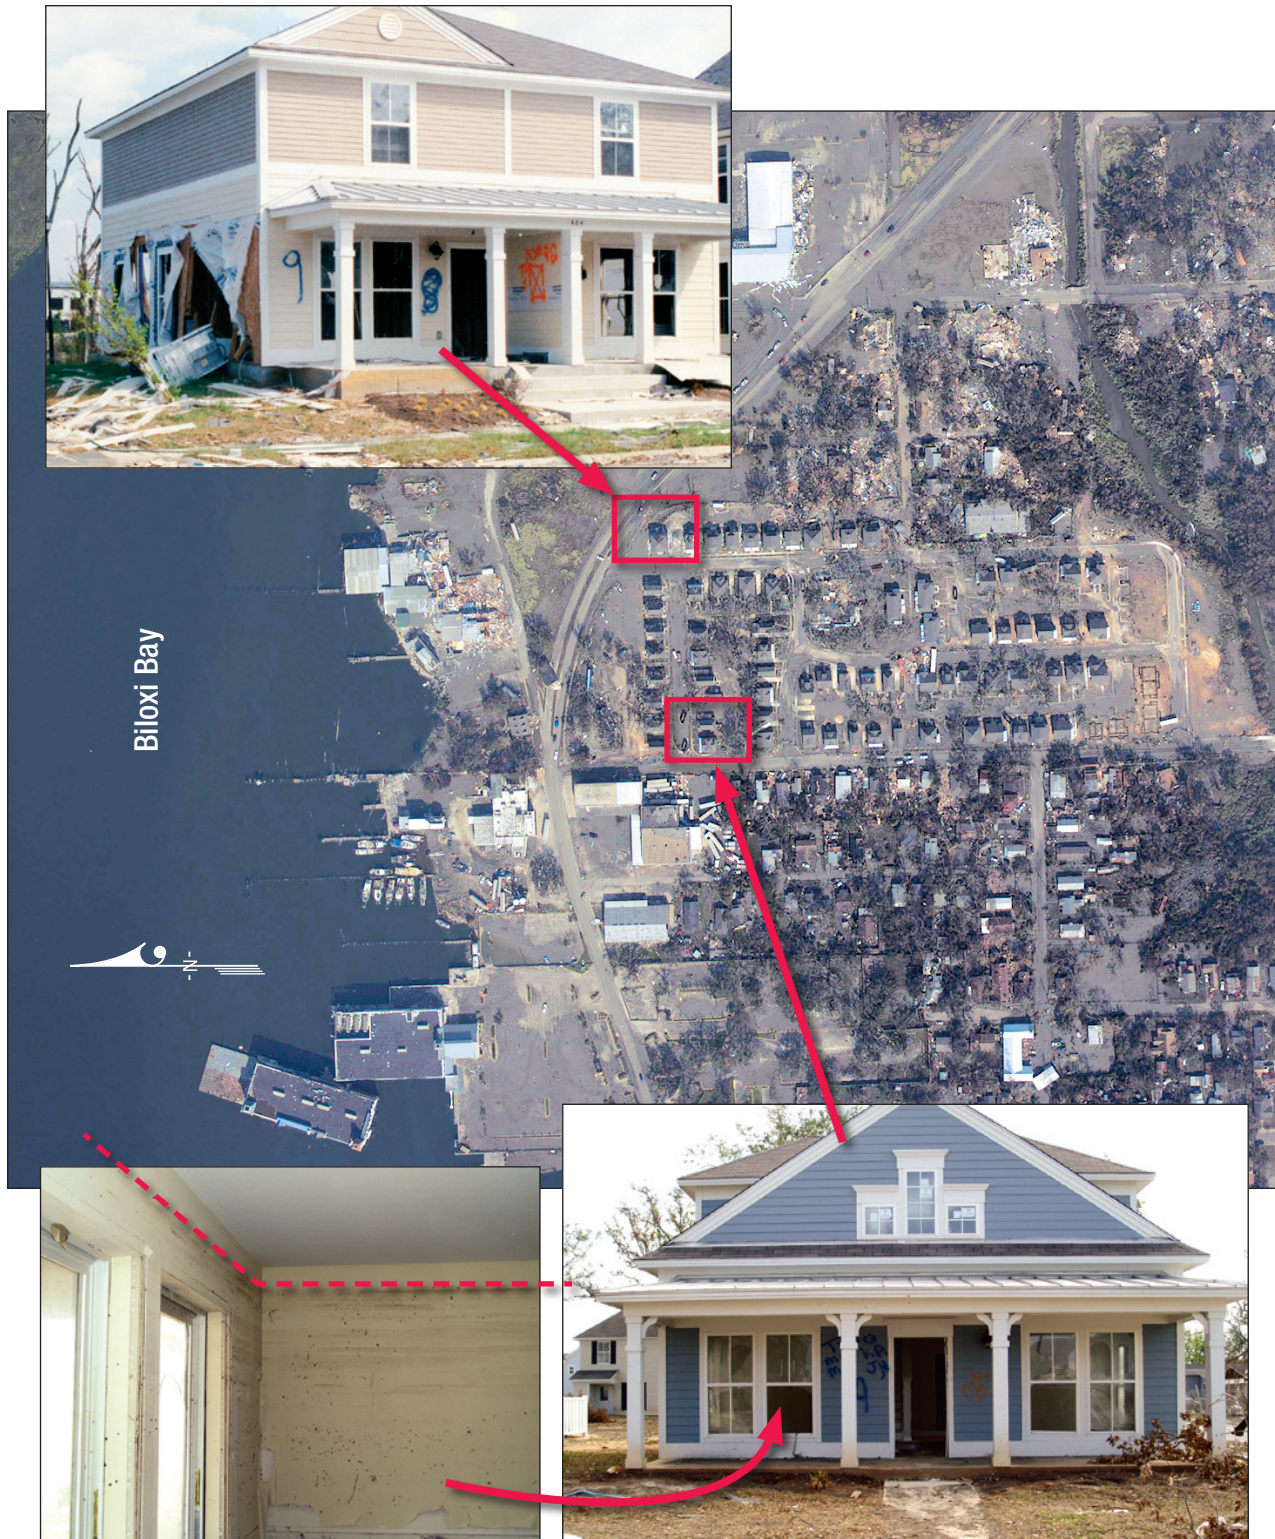
Figure 3-10.

This new public housing neighborhood (not yet occupied) was flooded by storm surge to the first floor ceilings. Houses closest to the bay also sustained damage to walls by waves and floodborne debris. The arrows indicate the locations of the inset photos (Biloxi, Mississippi).

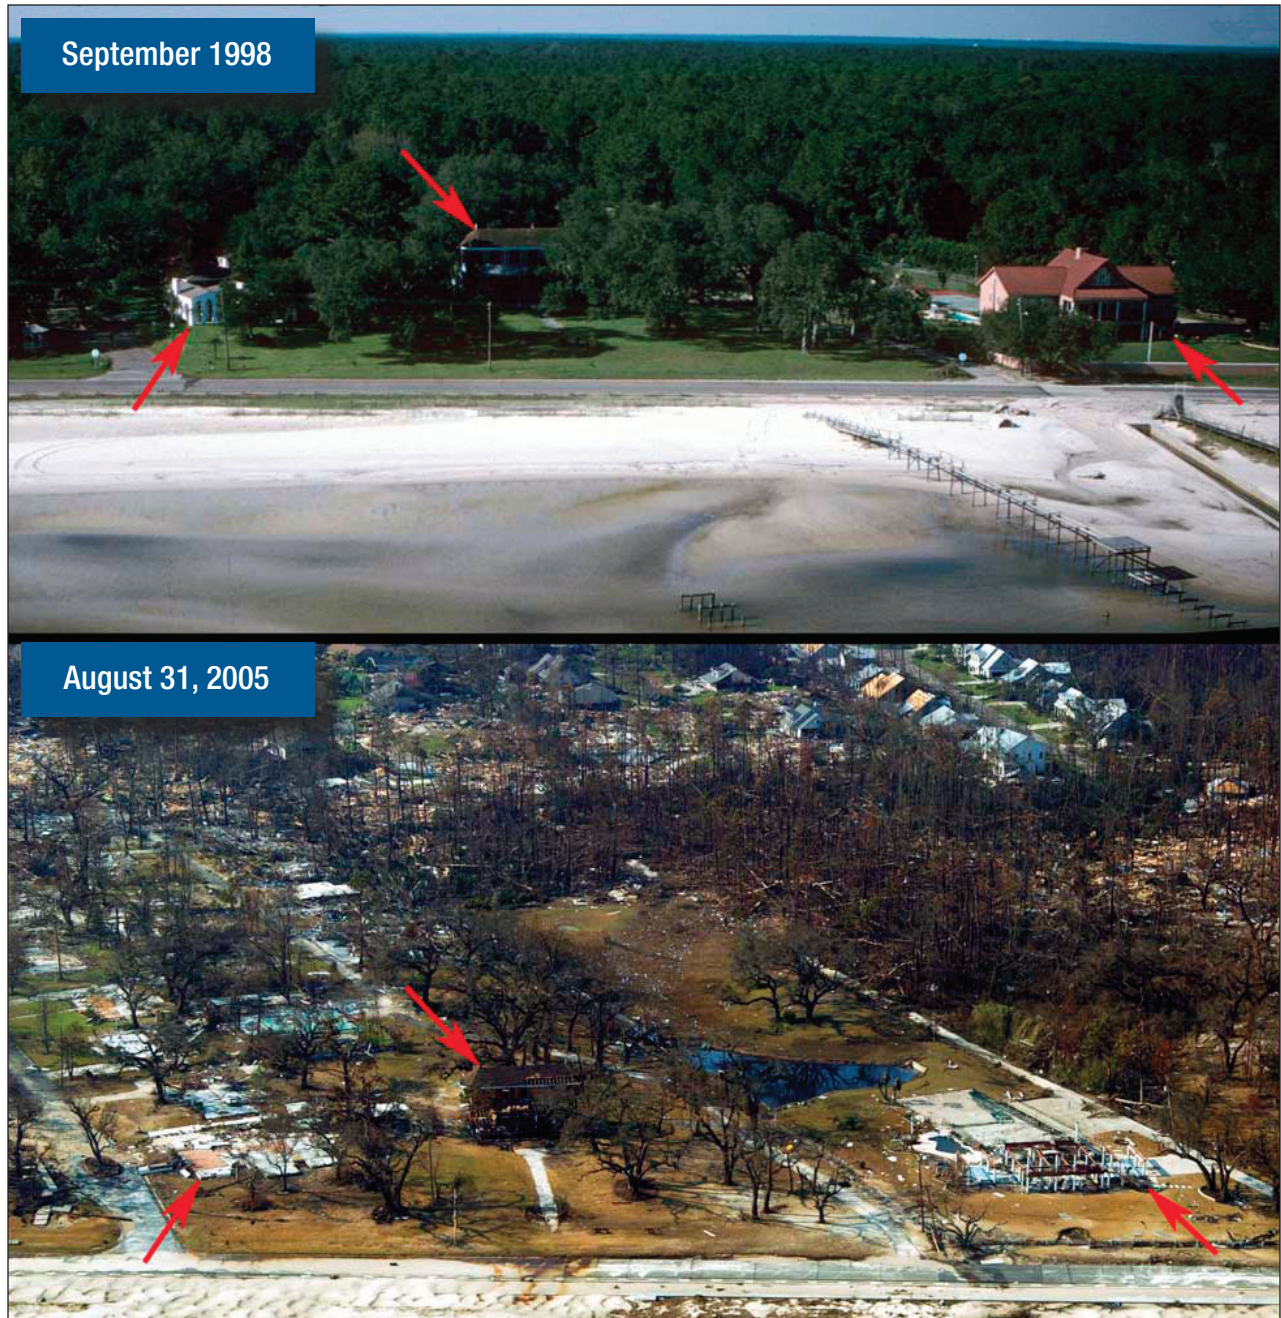
Figure 3-11.

Wave, floodborne debris, and surge damage to some Gulf-front neighborhoods was extreme. Arrows indicate locations of buildings in both photos (Waveland, Mississippi).

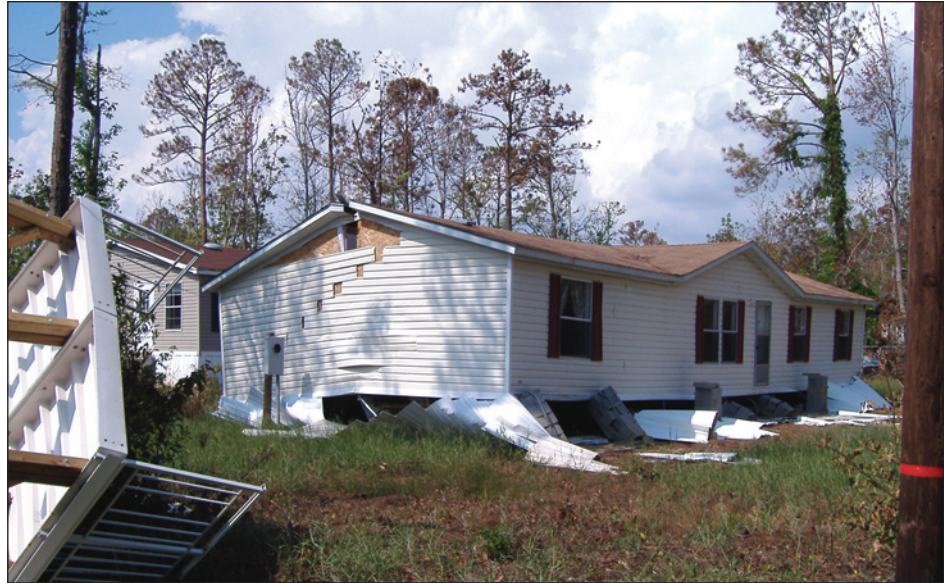
**Figure 3-12.**  
Manufactured home  
washed off its supports by  
moving floodwaters (Ocean  
Springs, Mississippi)

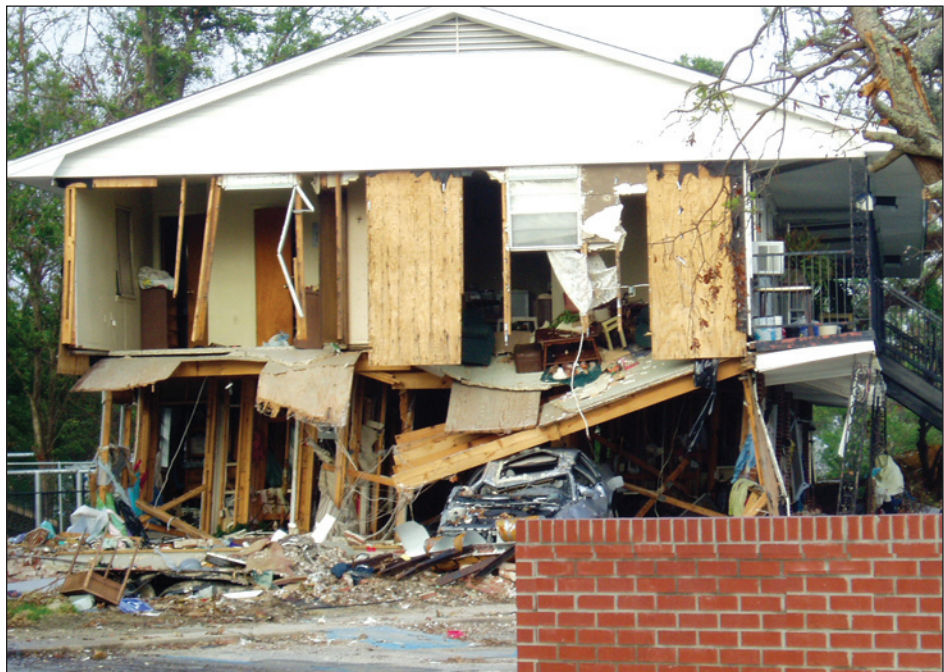
**Figure 3-13.**  
Apartments damaged  
by storm surge, floating  
automobiles, and wave  
action (Biloxi, Mississippi)

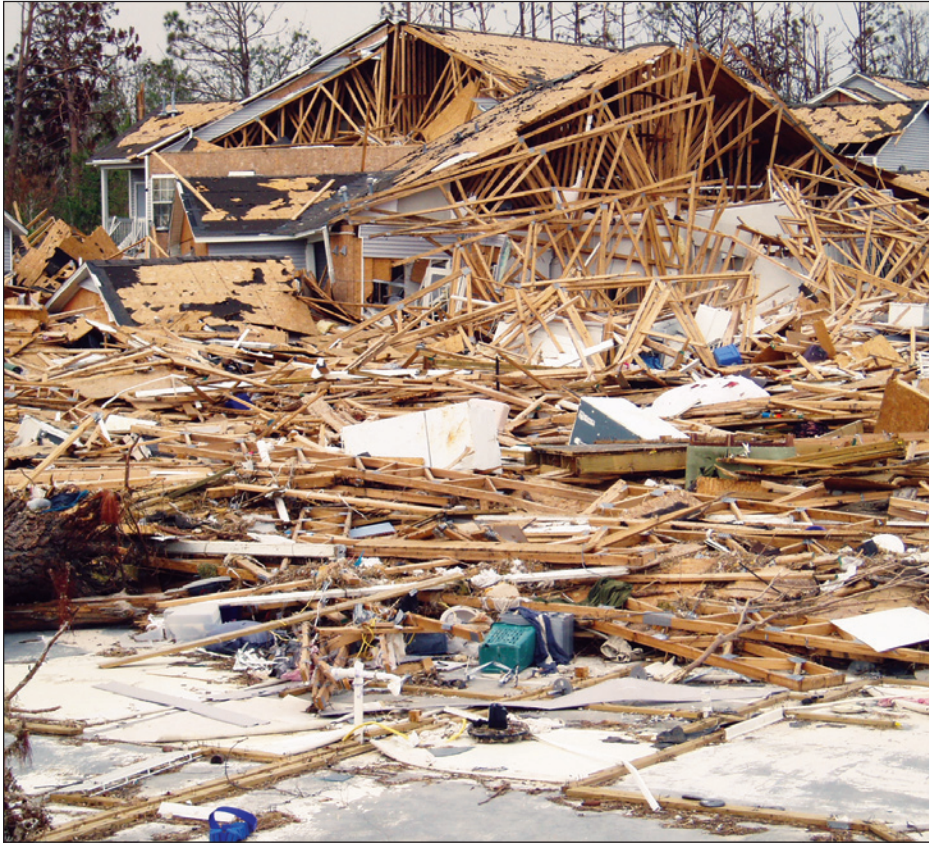
**Figure 3-14.**  
Apartments on slab foundations destroyed by waves, storm surge, and wind (Long Beach, Mississippi)

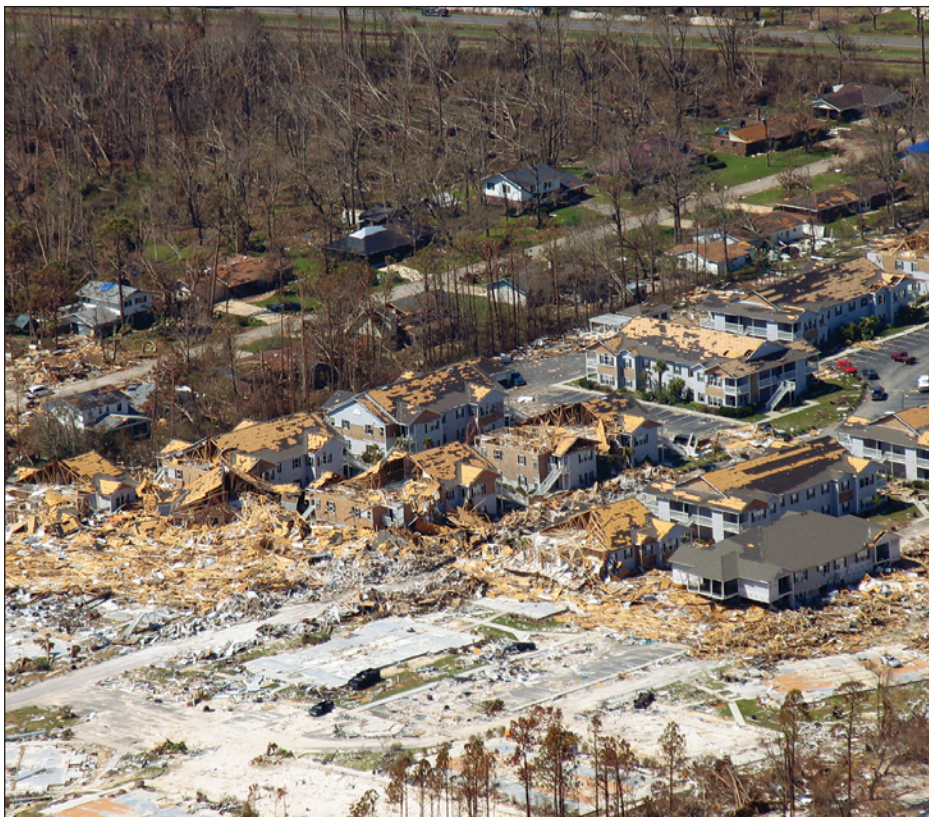
**Figure 3-15.**  
Aerial photo of apartment complex shown in Figure 3-14 and the surrounding area (Long Beach, Mississippi)

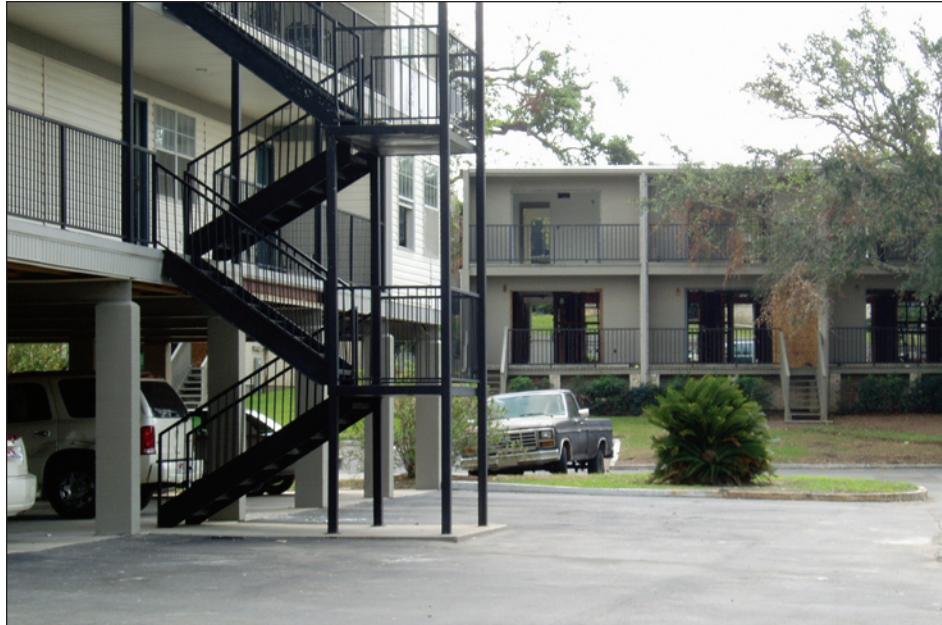
**Figure 3-16.**  
Wood-framed and masonry multi-family residential buildings damaged by storm surge (limited wave action). The building in foreground sustained flooding to a level approximately 30 inches above the elevated floor. The building in the background was flooded to the ceiling of the lower floor units (Ocean Springs, Mississippi).

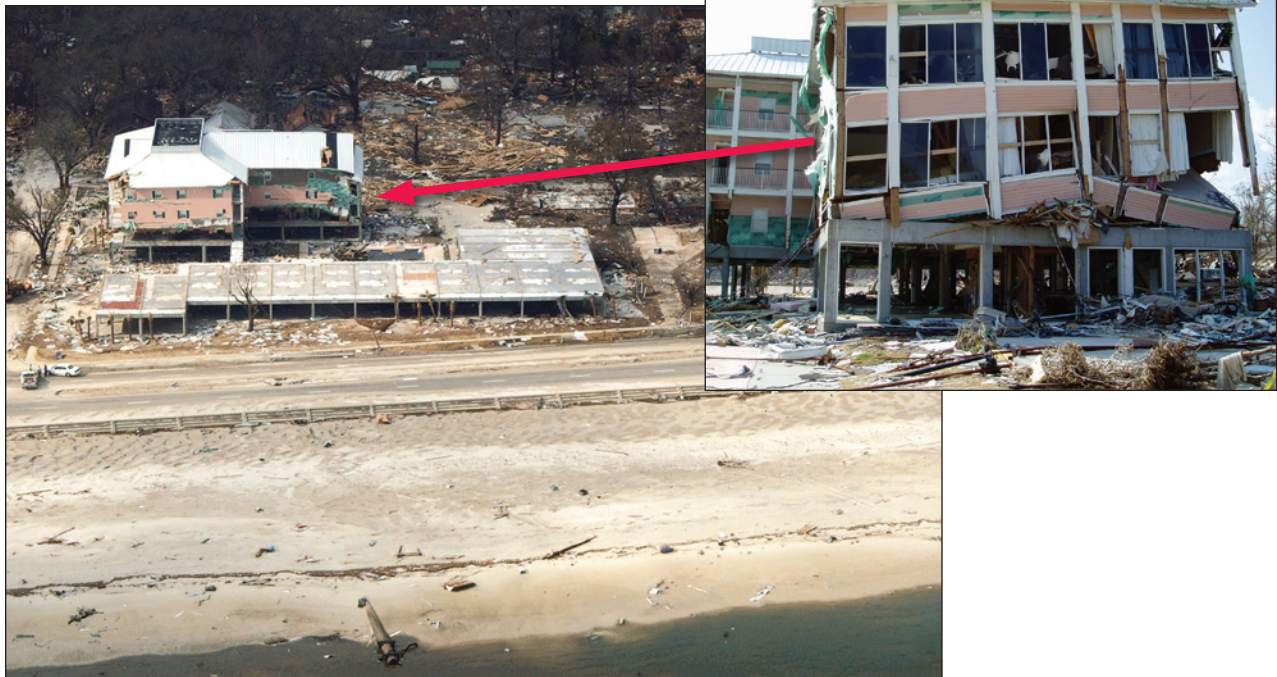
**Figure 3-17.**  
Wave and surge damage to Gulf-front apartments. Note the poured concrete foundation columns and slab performed well, but the waves rose above the slab and attacked the wood-framed buildings, destroying the building closest to the Gulf, and severely damaging the landward building. The severity of damage to the remaining building resulted in demolition (Biloxi, Mississippi).

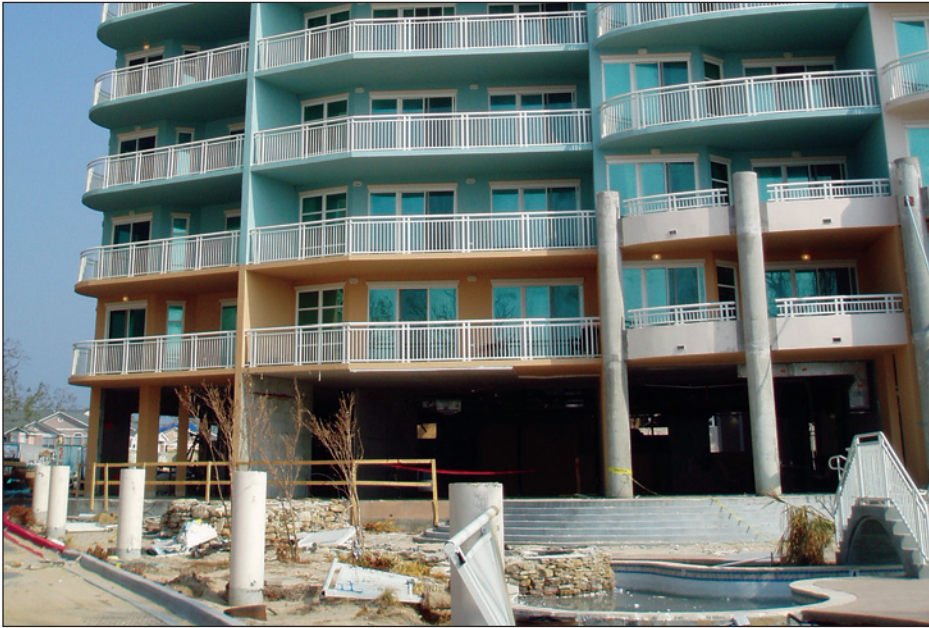
Figure 3-18. Waves and storm surge washed through the lowest floor of this condominium building, but the building reportedly sustained no structural damage (Gulfport, Mississippi).

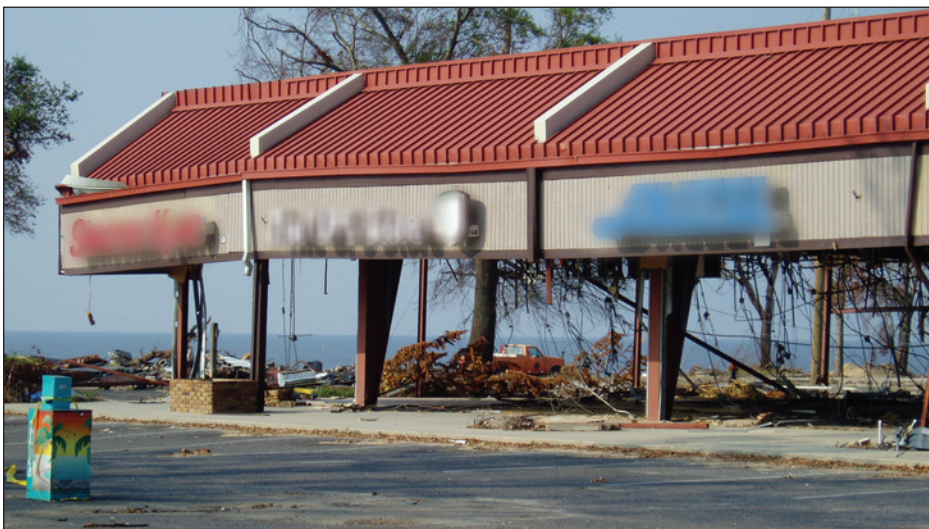
Figure 3-19. Strip mall with walls destroyed by waves and storm surge (Biloxi, Mississippi)

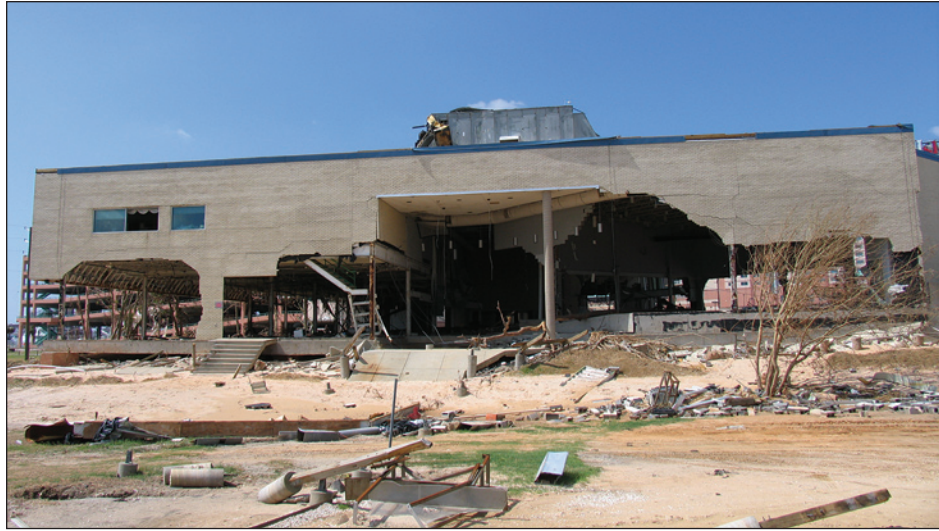
**Figure 3-20.**  
Marine Education Center,  
which lost most of  
its walls due to wave  
action, storm surge, and  
floating debris (Biloxi,  
Mississippi)

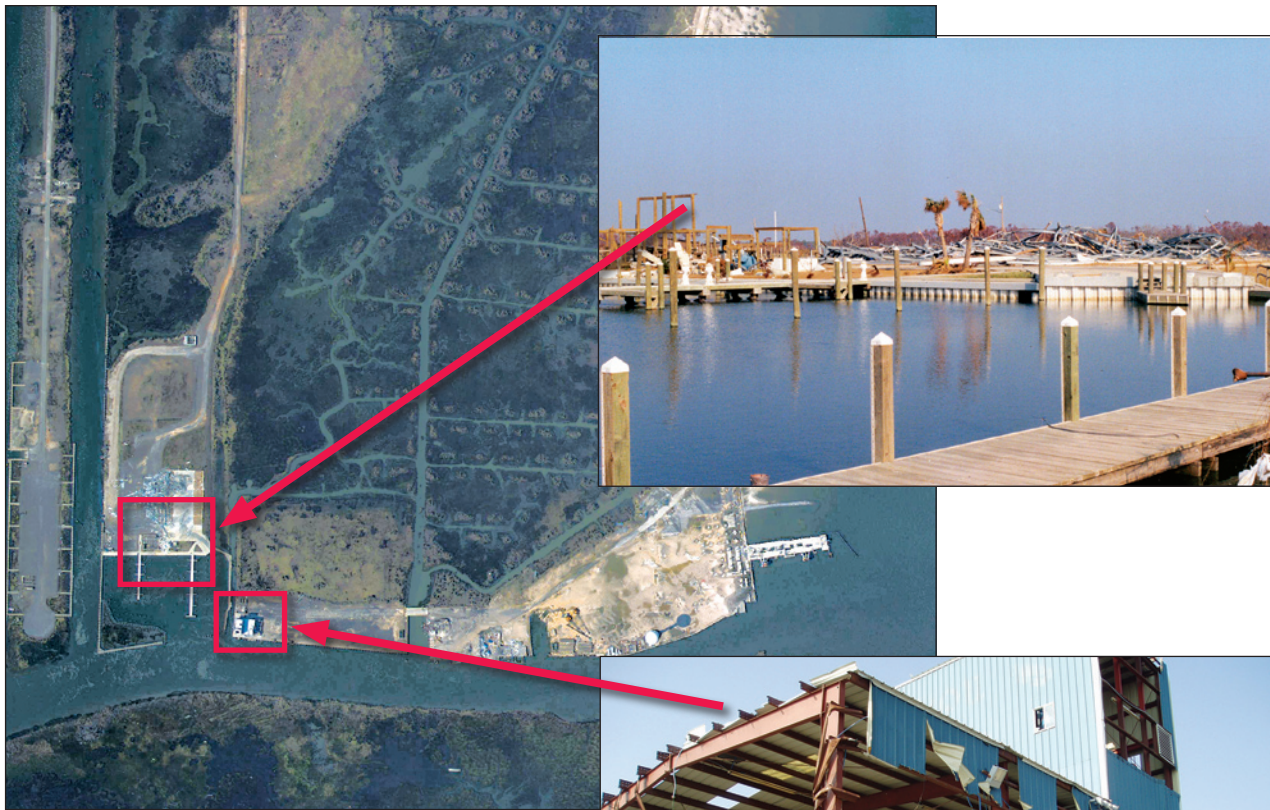
**Figure 3-21.**  
A reinforced concrete and pre-engineered metal  
building (PEMB) housing a seafood processing  
building sustained severe damage due to storm  
surge, waves, and floating debris. Nearby marina  
buildings were also destroyed (Lakeshore area,  
Hancock County, Mississippi).

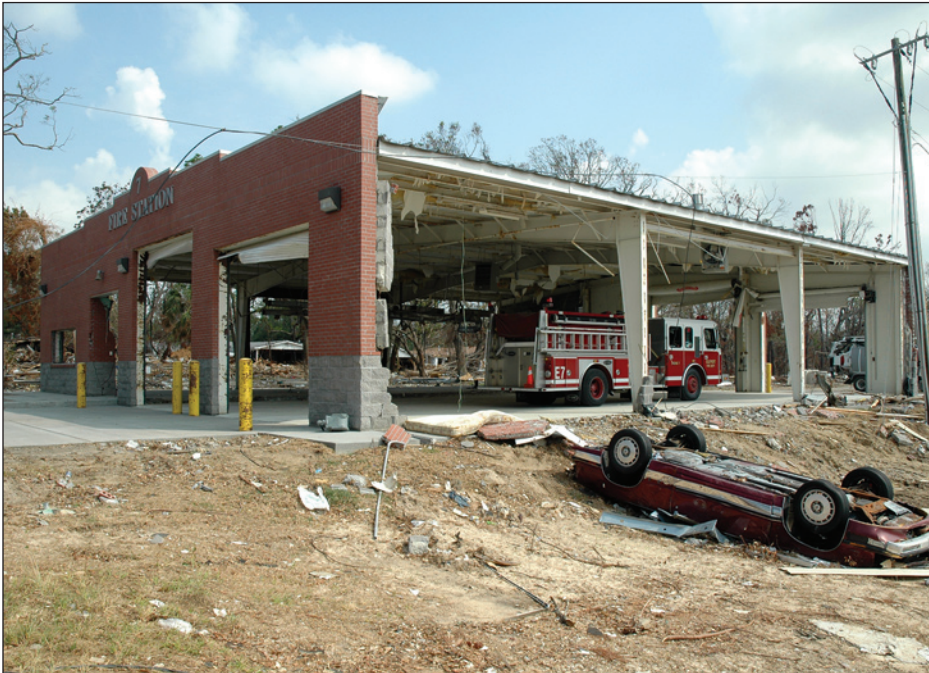
Figure 3-22.  
Newly constructed  
Gulfport Fire Station #7  
destroyed by waves and  
storm surge (Gulfport,  
Mississippi)

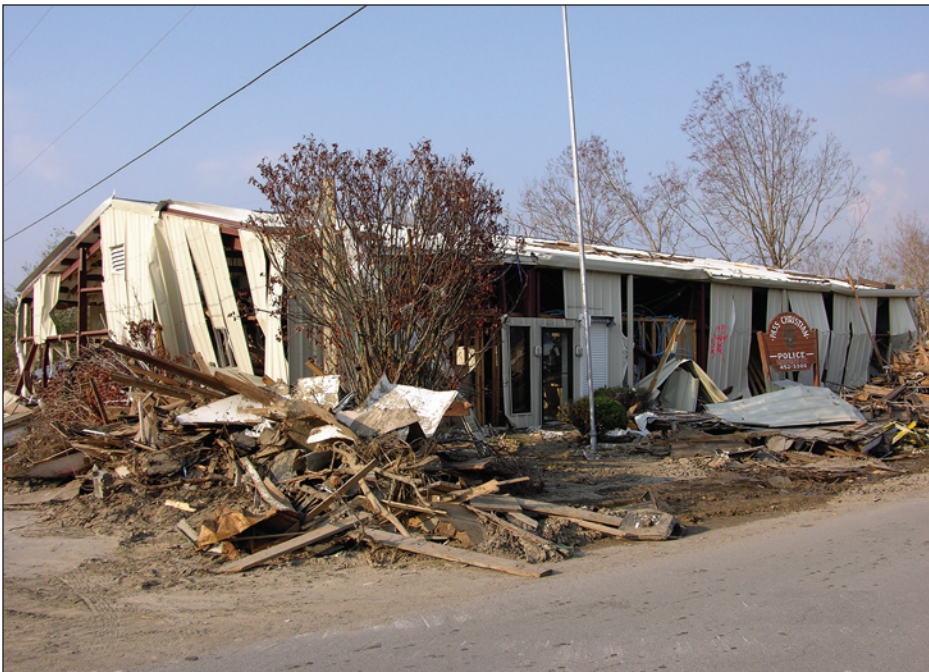
Figure 3-23.  
Pass Christian Police  
Department destroyed  
by storm surge (Pass  
Christian, Mississippi)

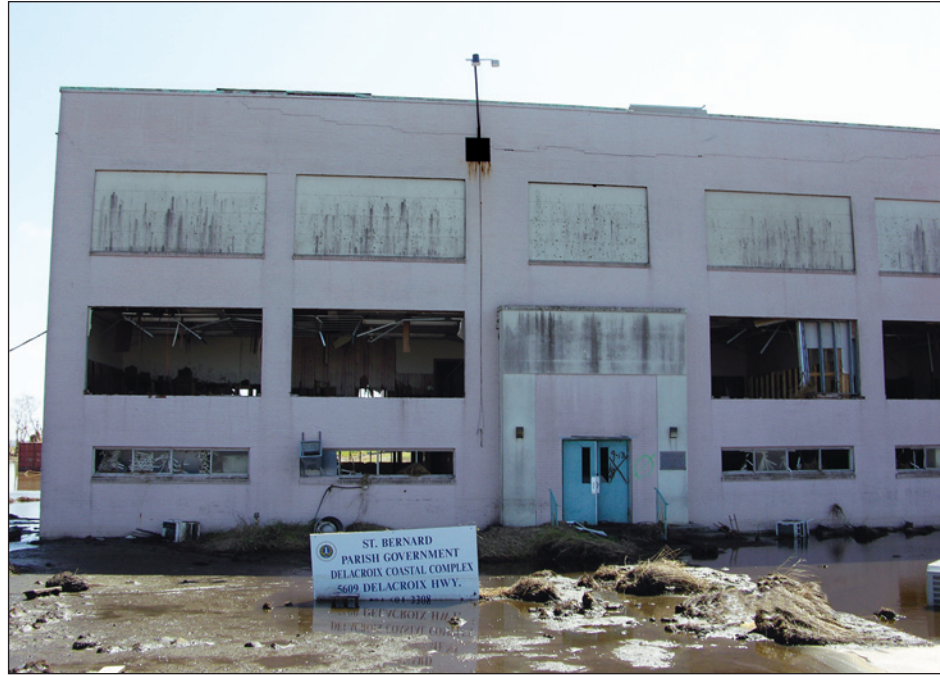
**Figure 3-24.**  
Storm surge damage to  
the St. Bernard Parish  
Coastal Government  
Complex (Delacroix,  
Louisiana)

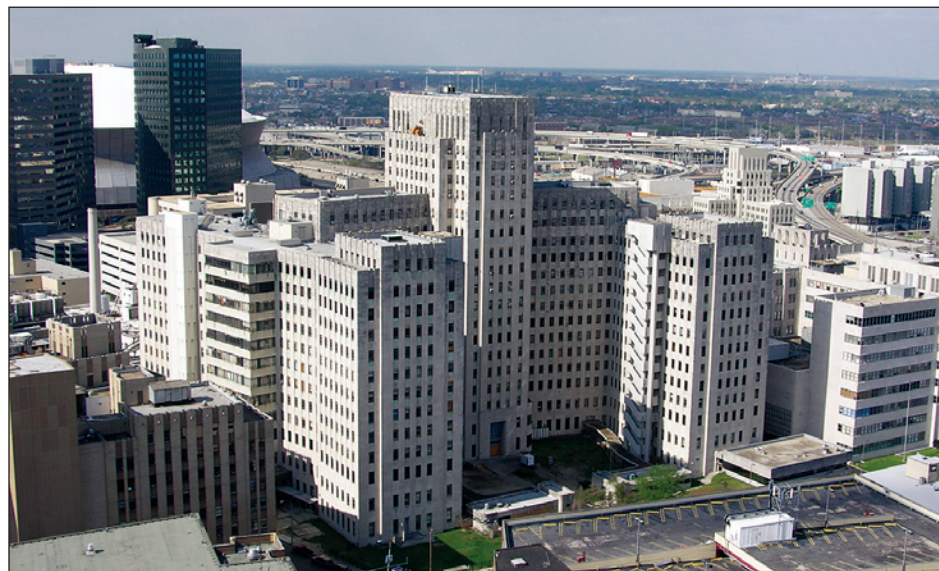
**Figure 3-25.**  
Floodwater isolated  
Charity Hospital and  
incapacitated its  
emergency generator  
(New Orleans, Louisiana)

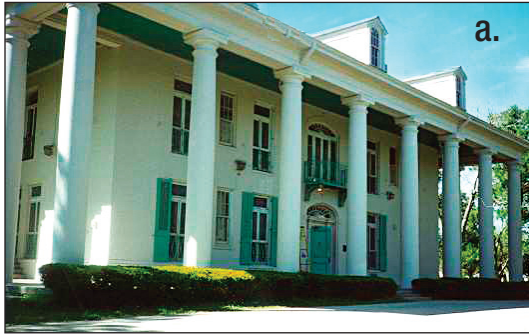
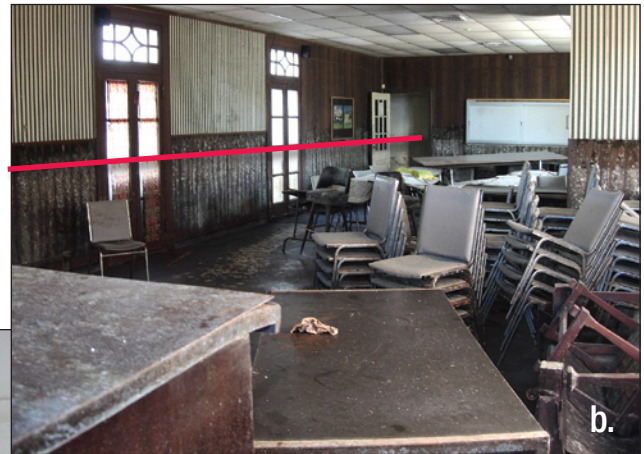
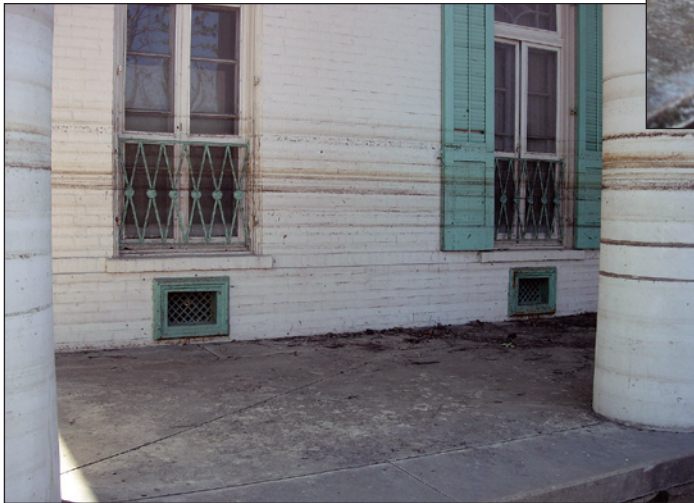
Figure 3-26.

a. This house (actually, one of three houses that make up the Milne Boys Home) had an interior flood depth of 3 feet.

b. and c. Water marks on the interior and exterior of the Milne Boys Home indicate the level of flooding that occurred as a result of Hurricane Katrina (New Orleans, Louisiana).

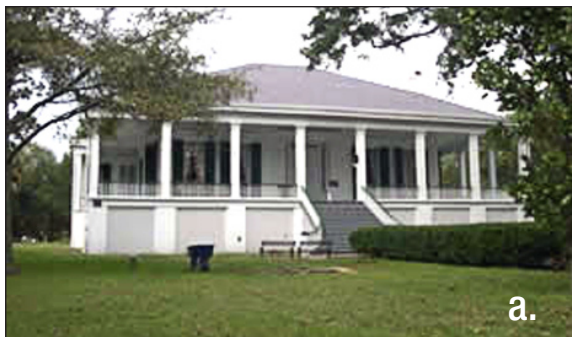
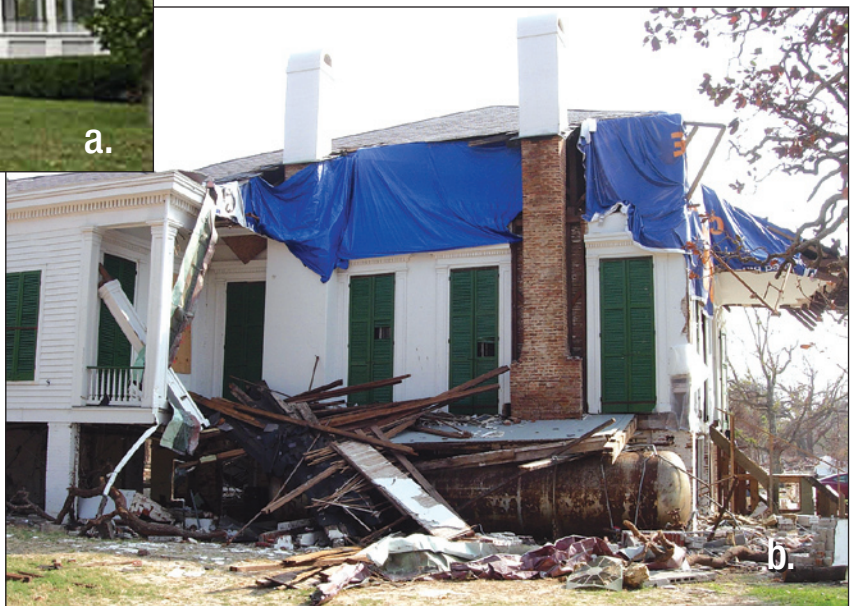
Figure 3-27.

Before (a.) and after (b.) photos of Beauvoir (Jefferson Davis' home), built in 1848. The building sustained severe surge damage from Hurricane Katrina's waves and storm surge (Biloxi, Mississippi).

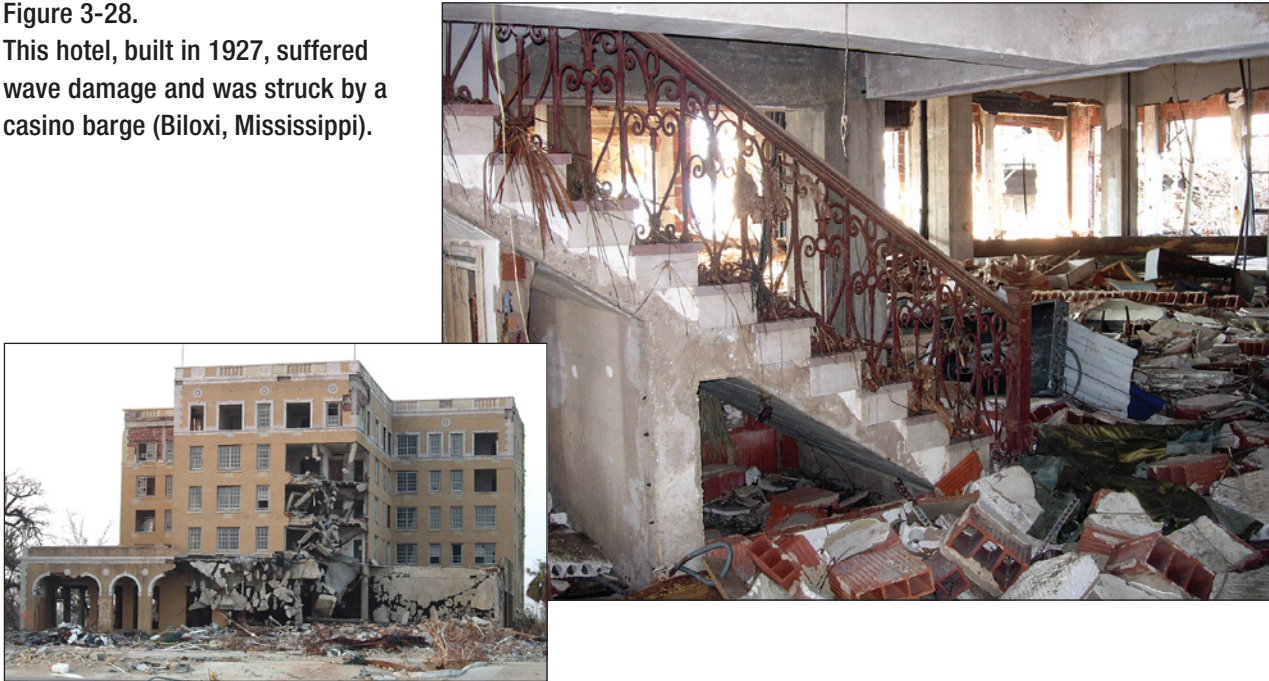
Figure 3-28.

This hotel, built in 1927, suffered wave damage and was struck by a casino barge (Biloxi, Mississippi).

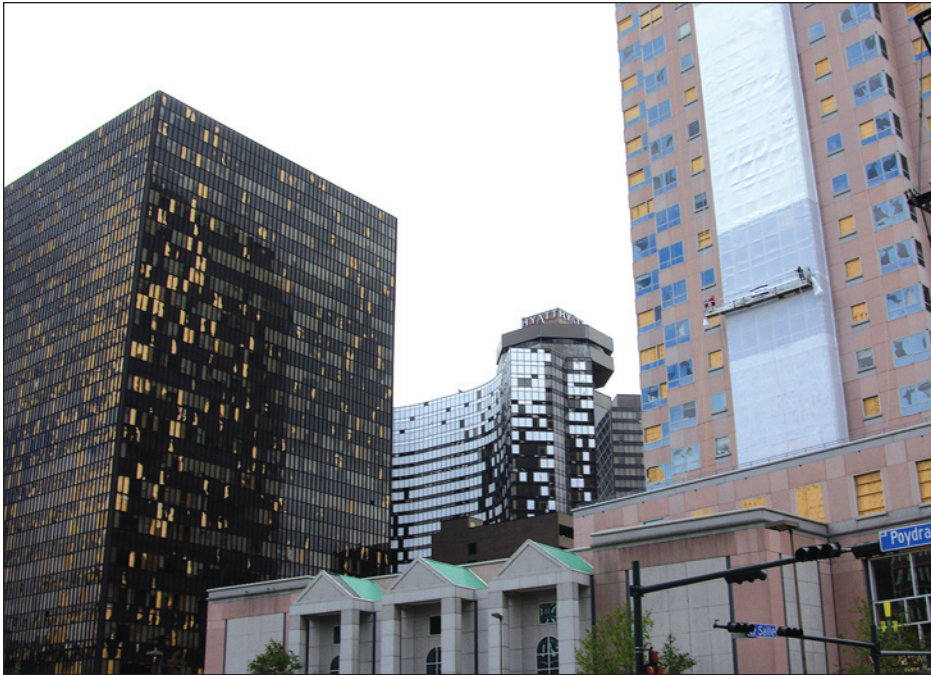
Figure 3-29.  
Roof aggregate was the primary windborne debris source for the window damage (New Orleans, Louisiana).

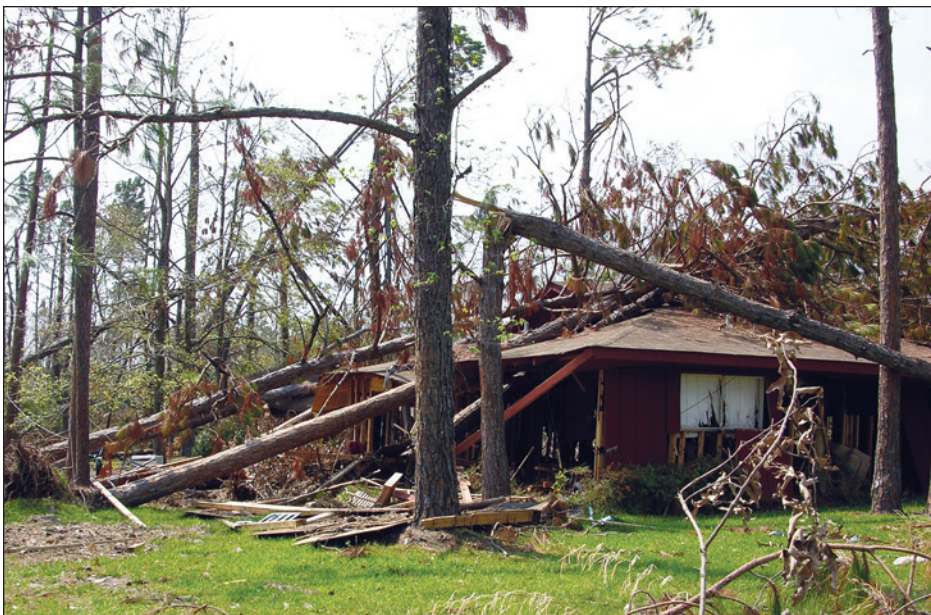
Figure 3-30.  
Tree-damaged home (Diamondhead, Mississippi)
